Re: Summary of Tankfield 3 Incident & Response
Hess Corporation Former Port Reading Complex (HC-PR)
750 Cliff Road
Woodbridge, Middlesex County, New Jersey
NJDEP PI# 006148
ISRA Case No. E20130449
EPA ID No. NJD045445483

Impacted Stone Remediation

Attachment F Photographic Log 8/18/2021 Tankfield 3 - Stained Stone Removal Area Port Reading Terminal Woodbridge, NJ

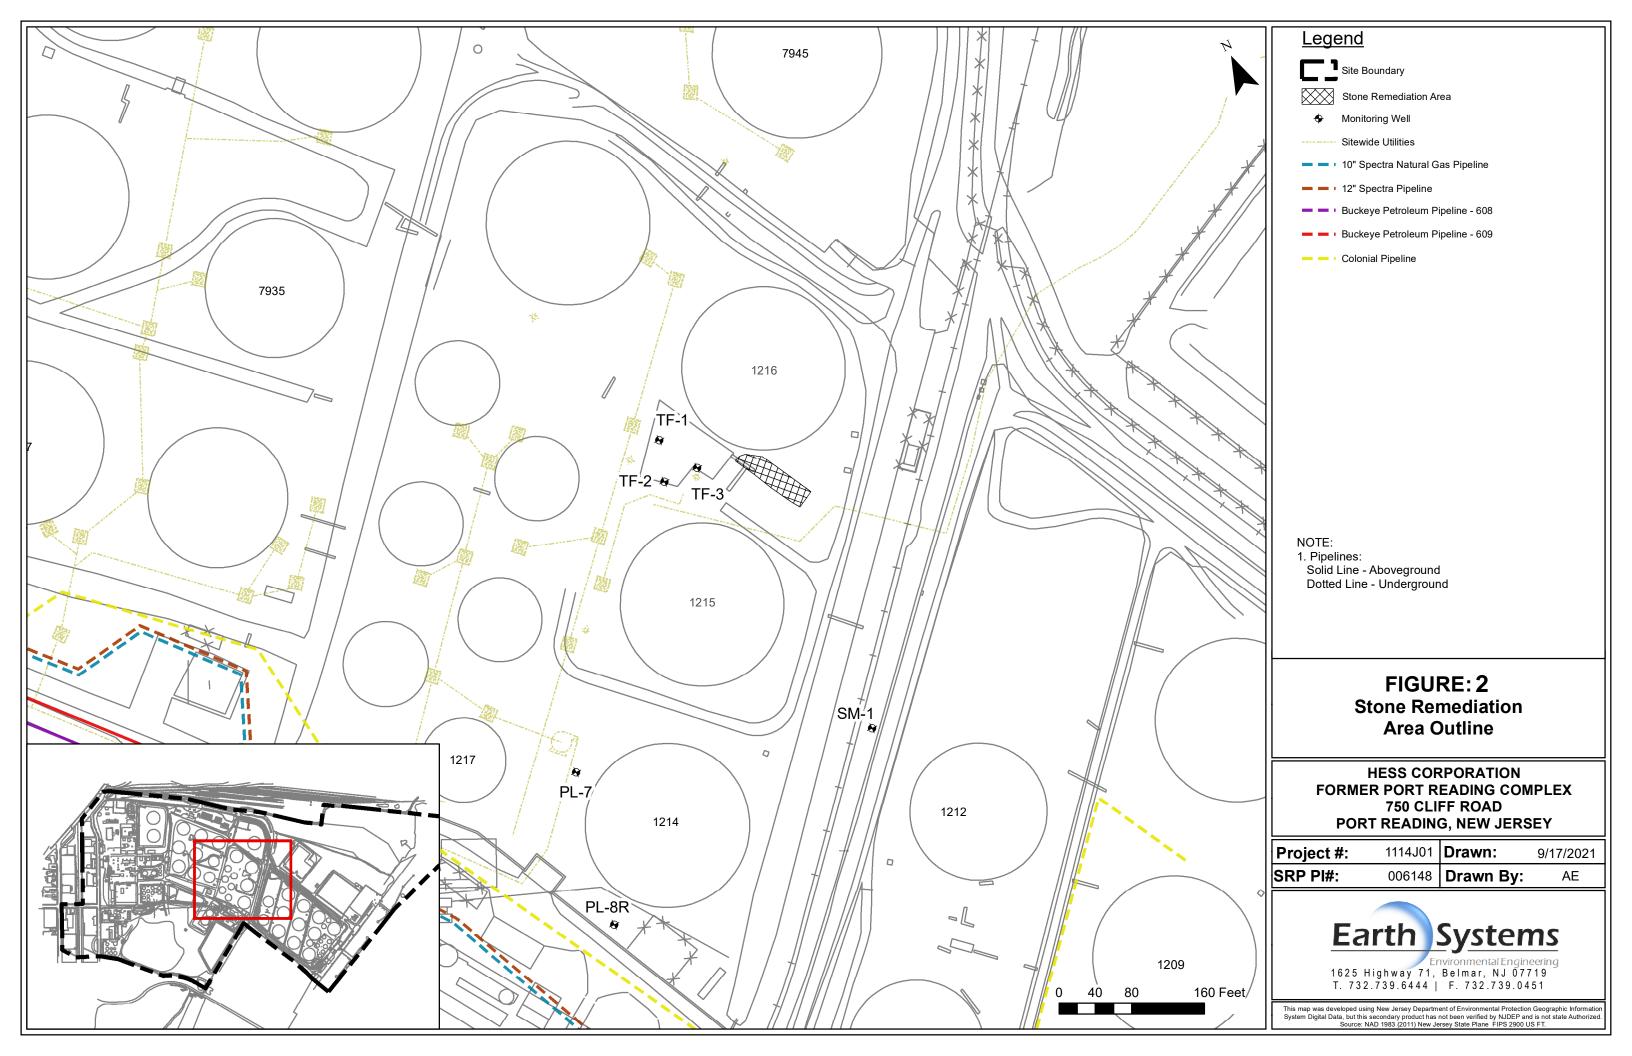
As part of the response to this incident, groundwater samples were collected from the Tankfield 3 monitoring wells on March 25, 2021. The monitoring wells are located adjacent to the location of the observed LPH. The monitoring wells were gauged prior to sampling and no product was detected in the wells. Benzene was detected at a concentration of 82.8 parts per billion (ppb) in the groundwater sample collected from monitoring well TF-2, which is a higher concentration than detected historically in this well. In addition, ethyl benzene, toluene, and xylenes were also detected in the groundwater sample collected from this well at concentrations significantly higher than historic results. A summary table of the groundwater results is included below. The location of the monitoring wells and the analytical results are summarized on **Figure 2**. Laboratory reports are included in **Attachment B**.

The Tankfield 3 monitoring wells were gauged in April, on a biweekly basis, and a discontinuous layer of product was observed in monitoring well TF-2. There was not a sufficient amount of product present to measure with a probe. A sample of the product/groundwater was collected on April 23, 2021 and sent to SGS for fingerprint analysis. The product/groundwater sample was a match for diesel/fuel oil #2 (C9-C22) and motor oil. Please note that the product sample results collected from the tankfield

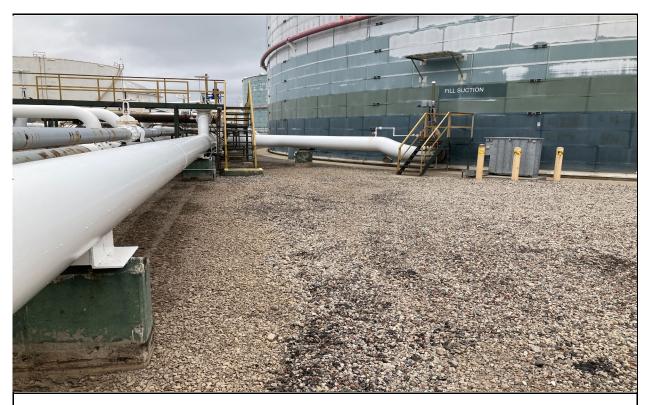
Photo 1: Tankfield 3 - Stained stone removal area 8/18/2021 8:44 AM

Earth Systems conducted an inspection of the LPH impacted area in Tankfield 3 and observed an isolated area of visually stained stone at the surface of the tankfield. On August 18, 2021, all visually impacted stone was excavated. The excavated area measured approximately 1,750 square feet (see **Figure 2**). The impacted stone was excavated using a small track skid steer and hand tools (shovels and rakes) to a maximum depth of approximately 2-inches. Visually impacted stone was only observed at the surface and a non-impacted layer of stone was encountered at the base of the excavation activities. No excavation activities extended into or breached the tankfield liner. An estimated eighteen (18) tons of impacted stone was removed for off-site disposal at a licensed facility. Disposal manifests are included in **Attachment D**. Following stone removal, the area was backfilled with certified clean ³/₄-inch gravel. Certified clean fill documentation is included in **Attachment E**.

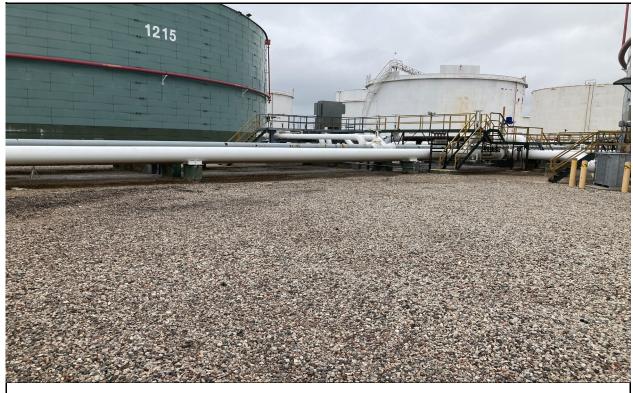
Photo 2: Tankfield 3 - Stained stone removal area 8/18/2021

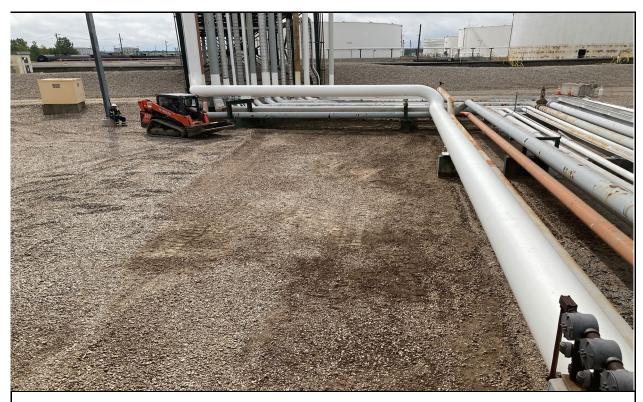
Photo 3: Tankfield 3 during stone removal activities - 10:36 AM

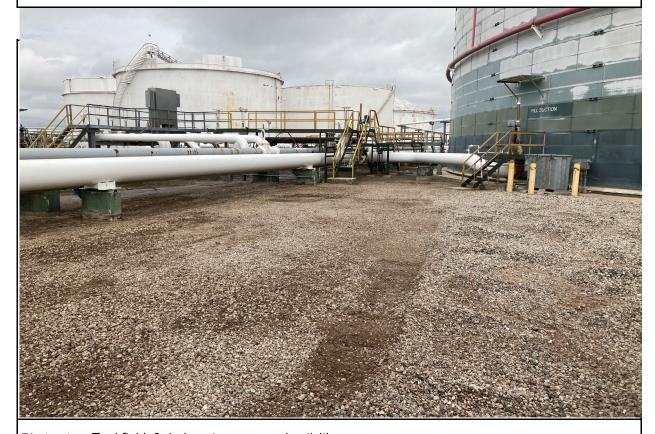
Photo 4: Tankfield 3 during stone removal activities

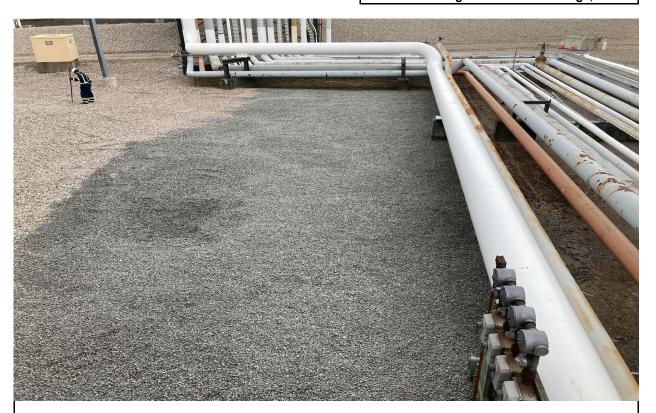
Photo 5: Replacement stone installed 1:03 PM

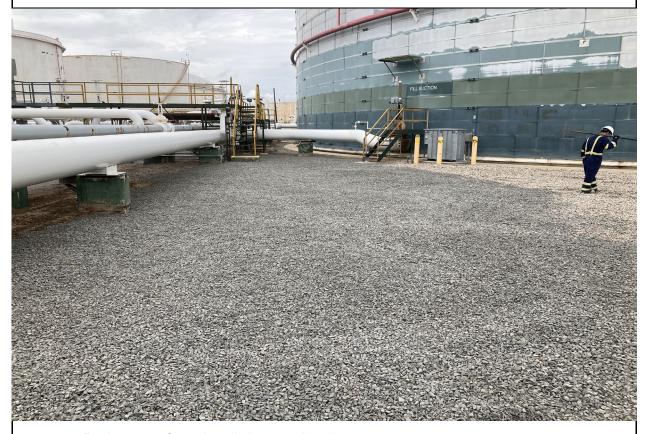
Photo 6: Replacement Stone installation completed.

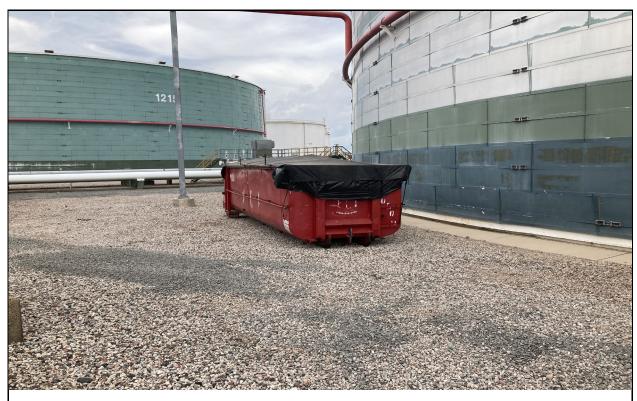
Photo 7: Secured stain stone roll-off
